5. FAULTS AND REMEDIES CHECK LIST

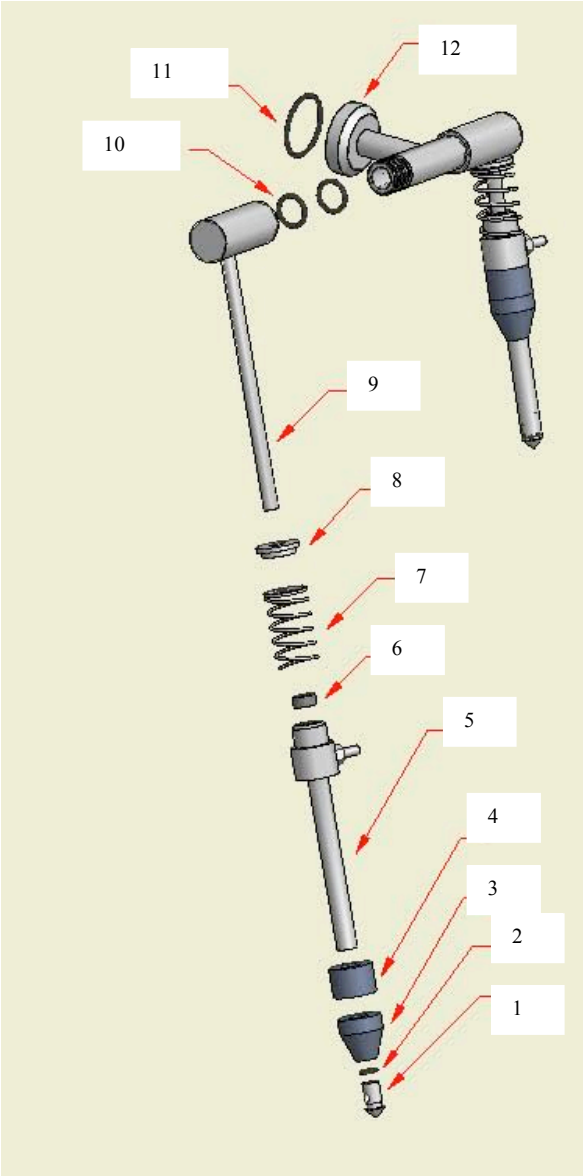
Picture 6.

If there is a leak, it is advisable to replace the gaskets which are near the dripping (see elements no. 2, no. 6 and no. 10, picture 6).
